TACTICAL BRIDGE ACCESS//GRESS PRELIMINARY
INVESTIGATIONS(U) ARMY ENGINEER WATERWAYS EXPERIMENT
STATION VICKSBURG MS GEOTECHNICAL LAB B A MATIS SEP 80

*Tactical Bridge Access/Egress
Preliminary Investigation*

Case, Gordon L.; Green, Hugh L.; Taylor, Hugh M. Sept. '80

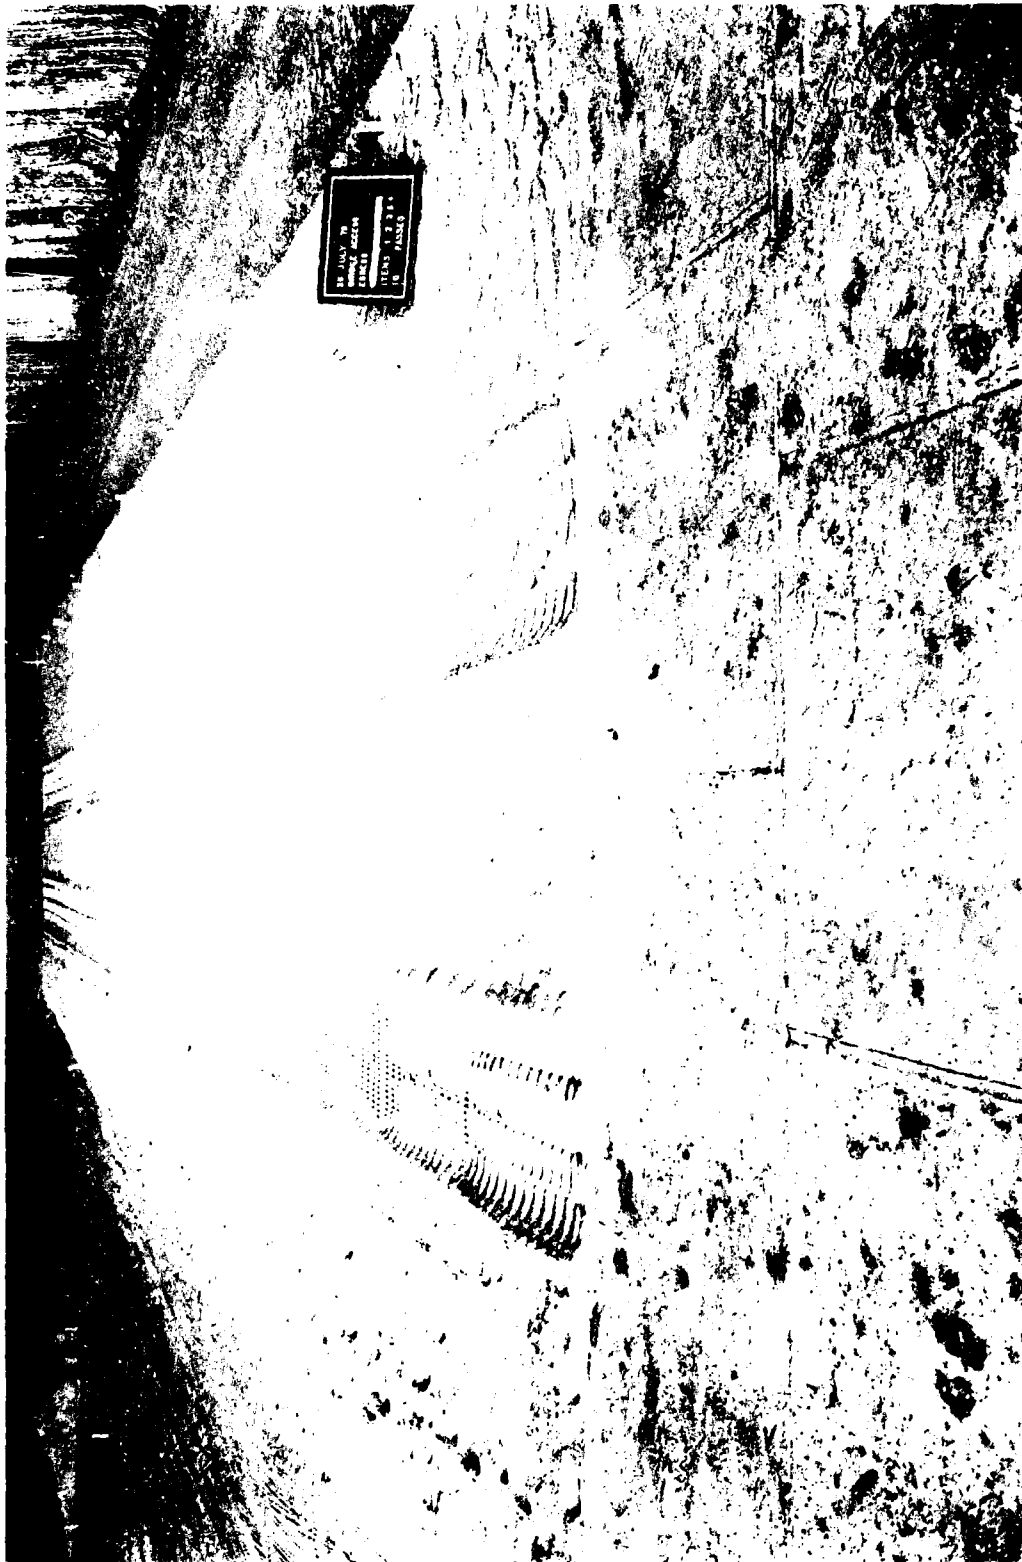
9. A view of the test section after 10 passes of traffic with the M54 truck is shown on Incl 22. Some rutting and compaction of the section had occurred. The sand was removed from some areas of the panels; however, no damage to the panels was observed. Details of the individual items are given in the following paragraphs.

Test section after 10 passes of traffic

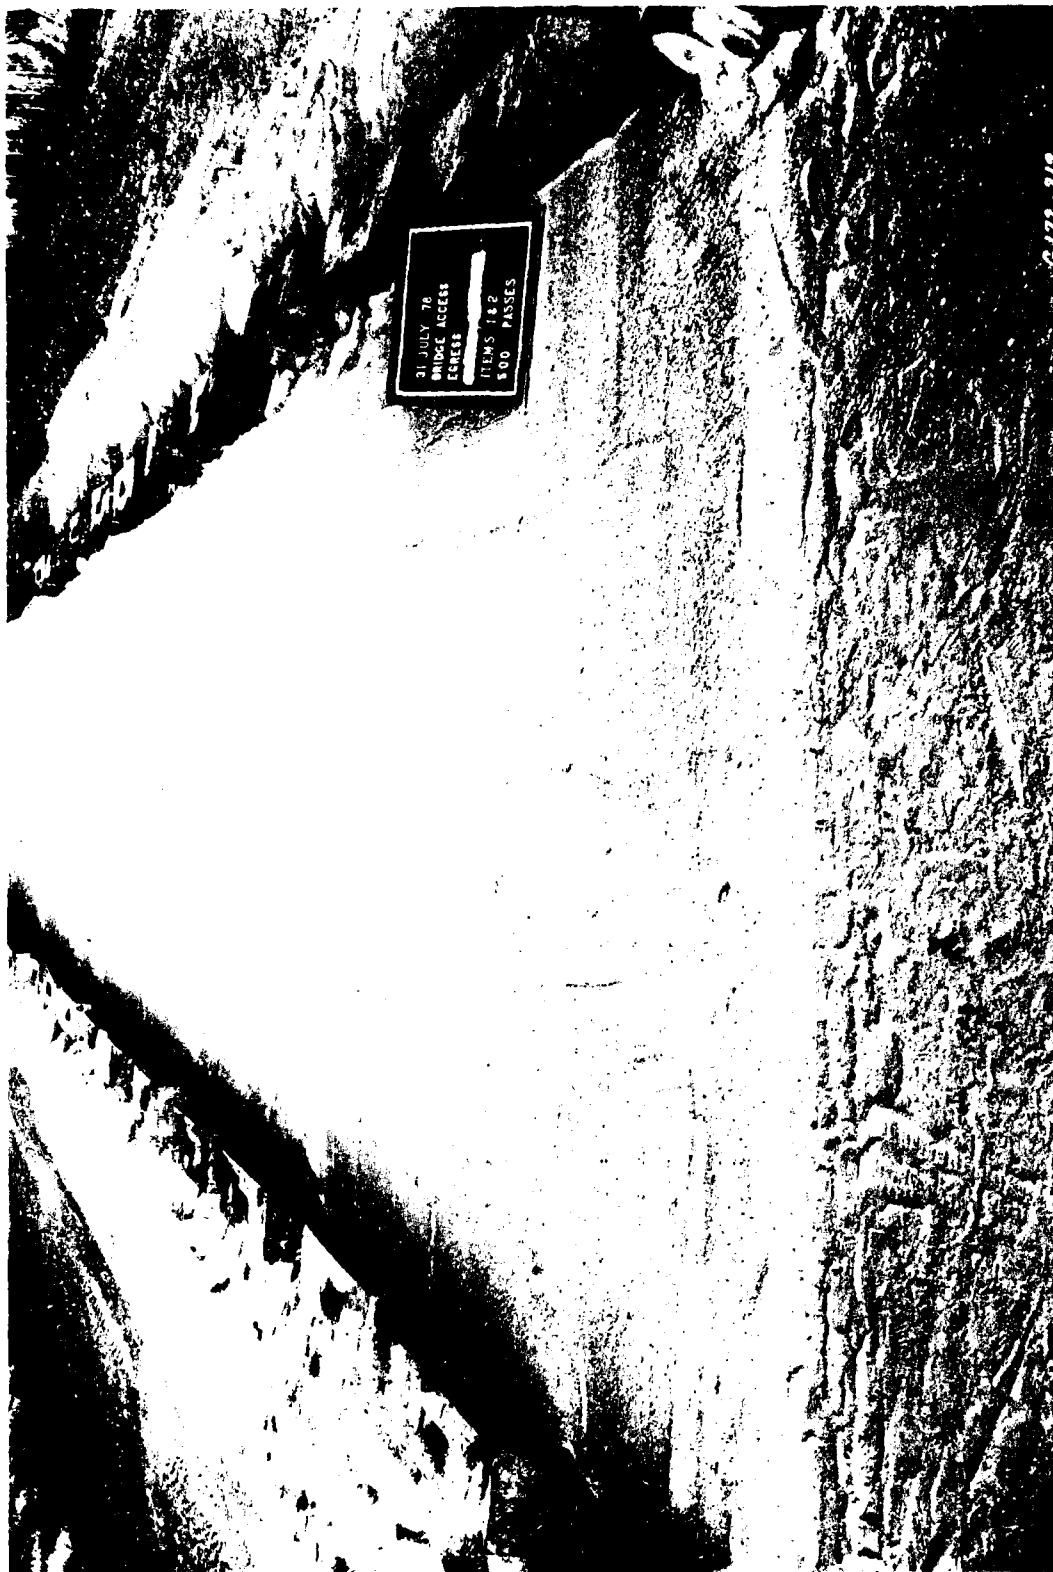
Incl 32.

f. The action of the test vehicle (20,000-lb gross load) after 200 passes on the Borden panels with and without membrane had caused the panels to work out of the sand. Some panels had gotten on top of each other; therefore, traffic was stopped and the section reworked. The panels were replaced on the section, steel weights were added along the edges to simulate an anchorage system, and the panels were overfilled with 2 in. of sand. After an additional 500 passes (700 total), the sand no longer covered the panels in the traffic lane. The panels were again covered with 2 in. of sand, and traffic continued until an additional 300 passes

Items 1 and 2 at 500 passes (panels overfilled with sand)

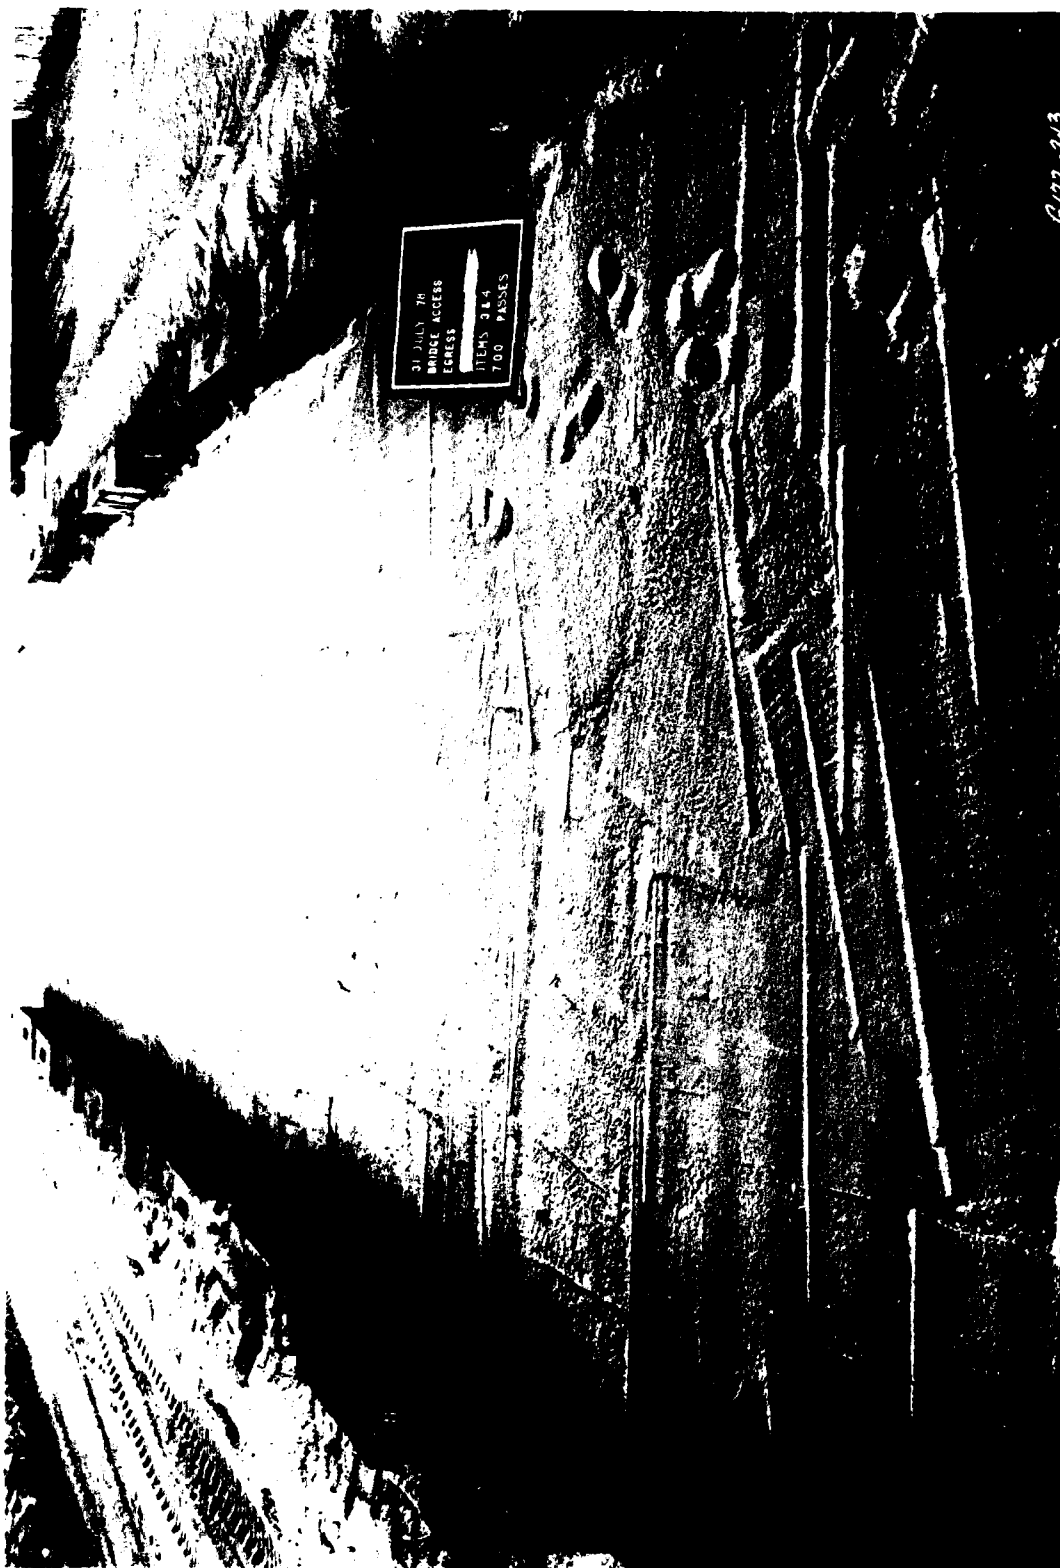
Incl 46.

Item 3 at 700 passes (reconstructed)

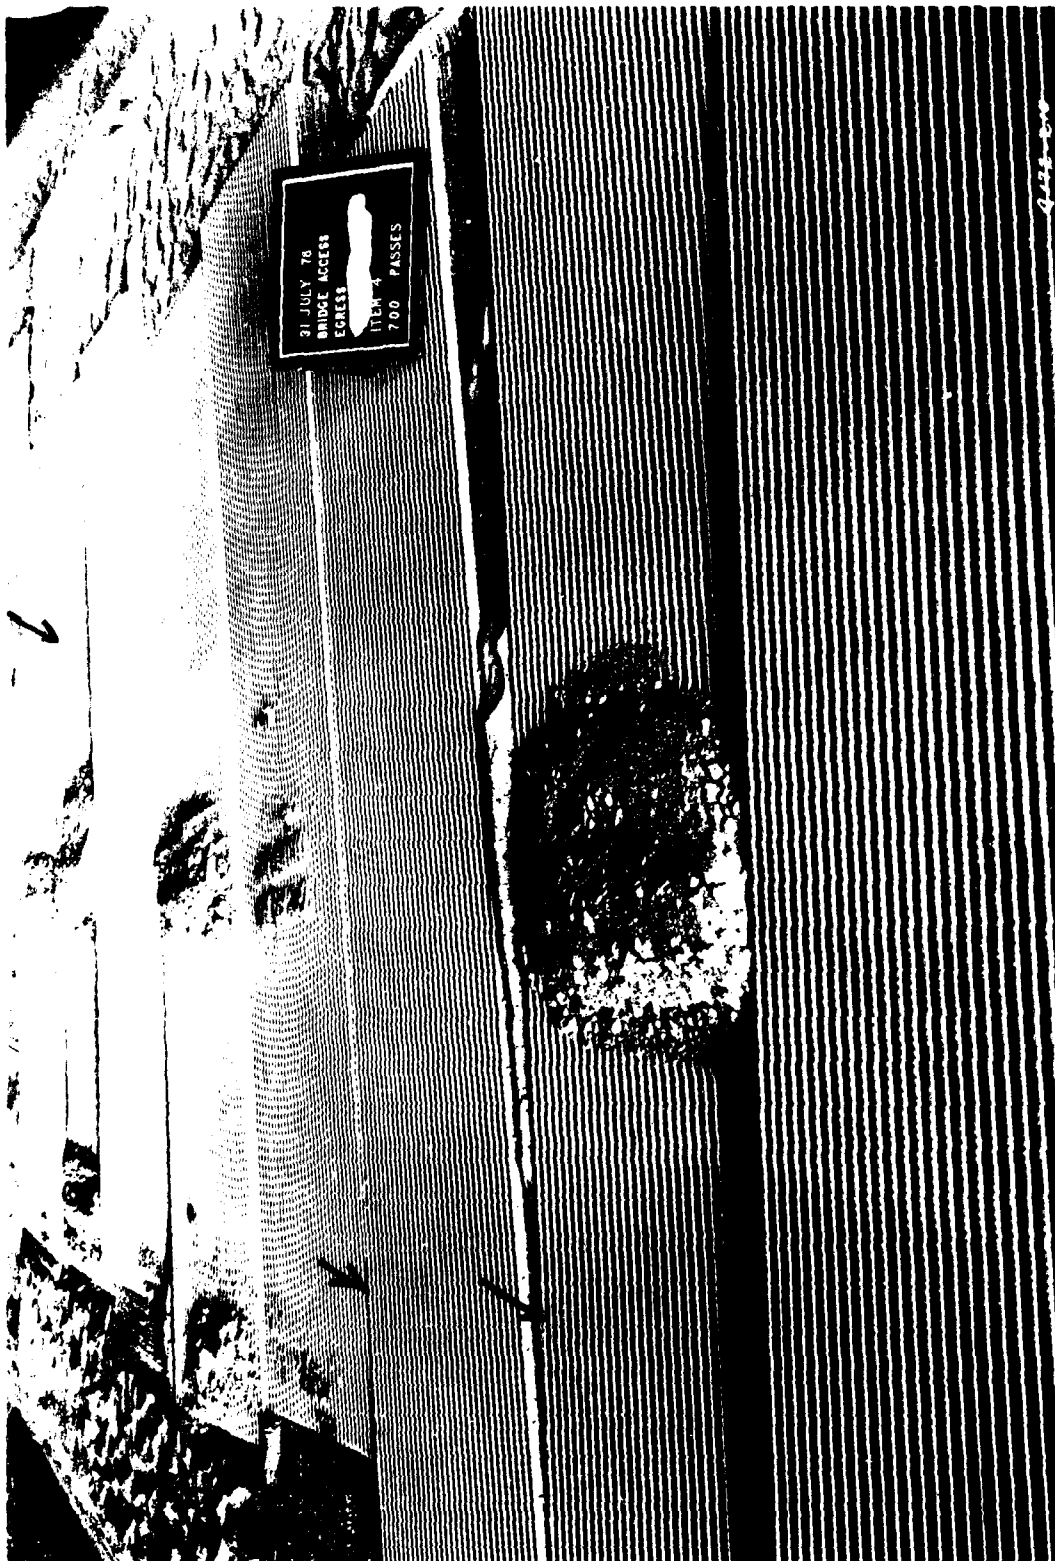
Incl 49.

Item 4 after 700 passes of traffic

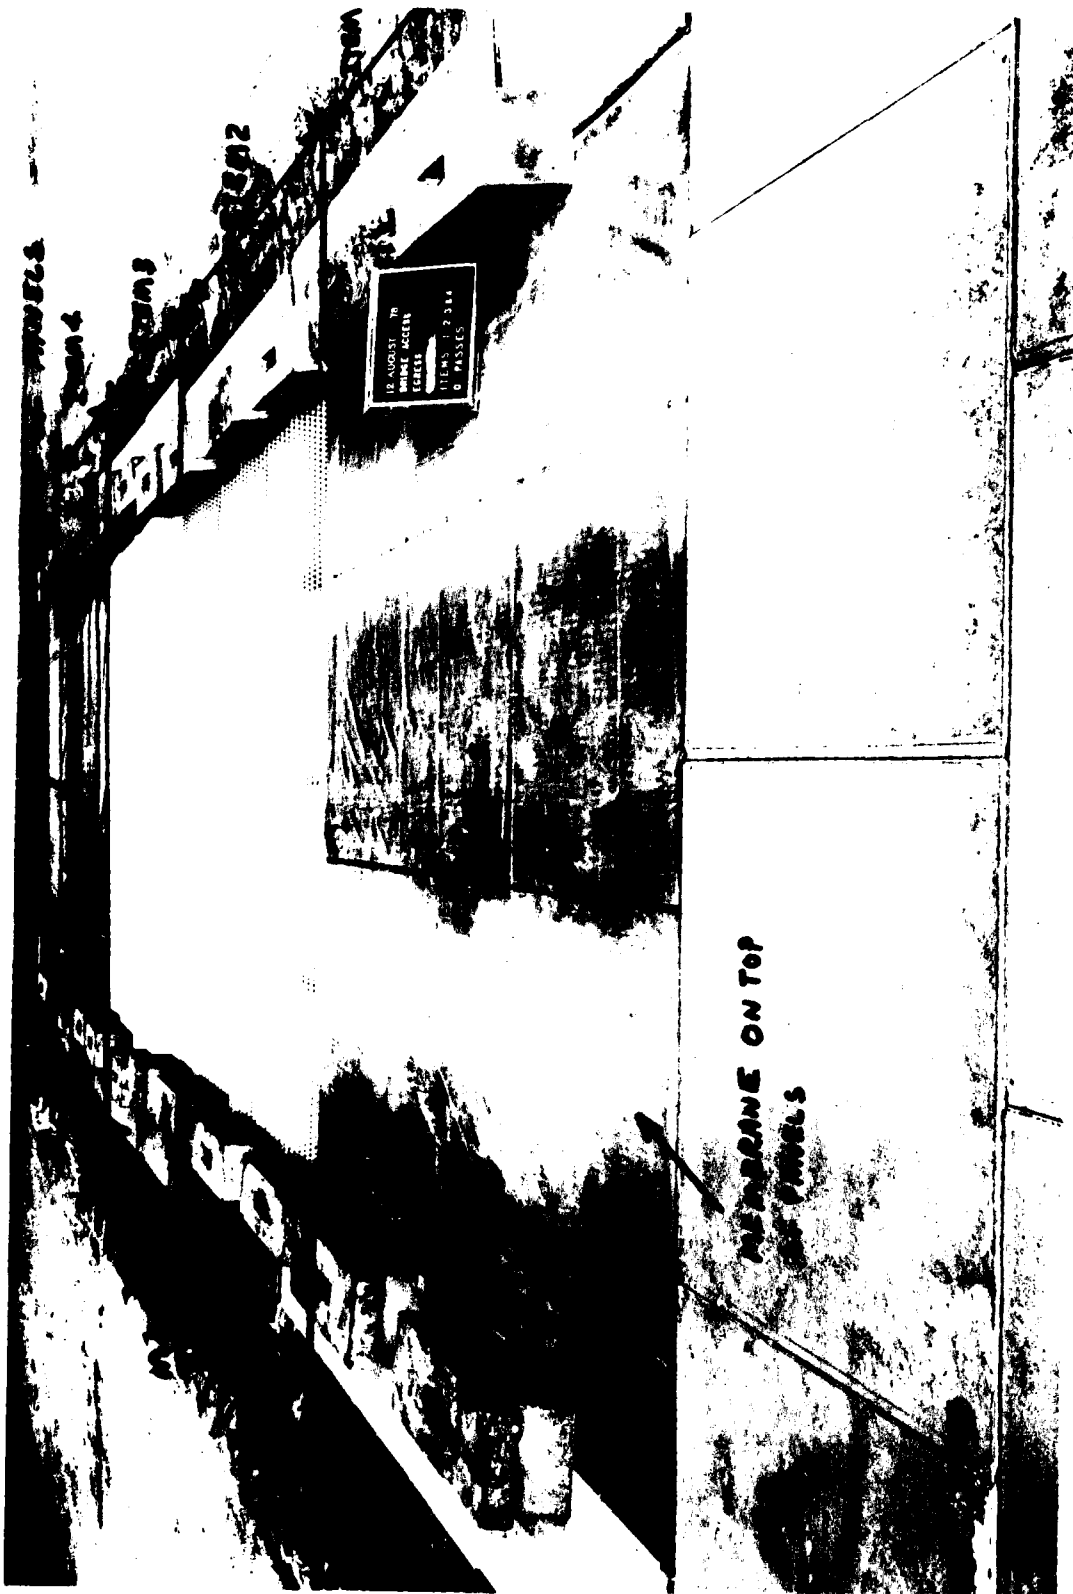
Test section (heavy clay subgrade) prior to traffic

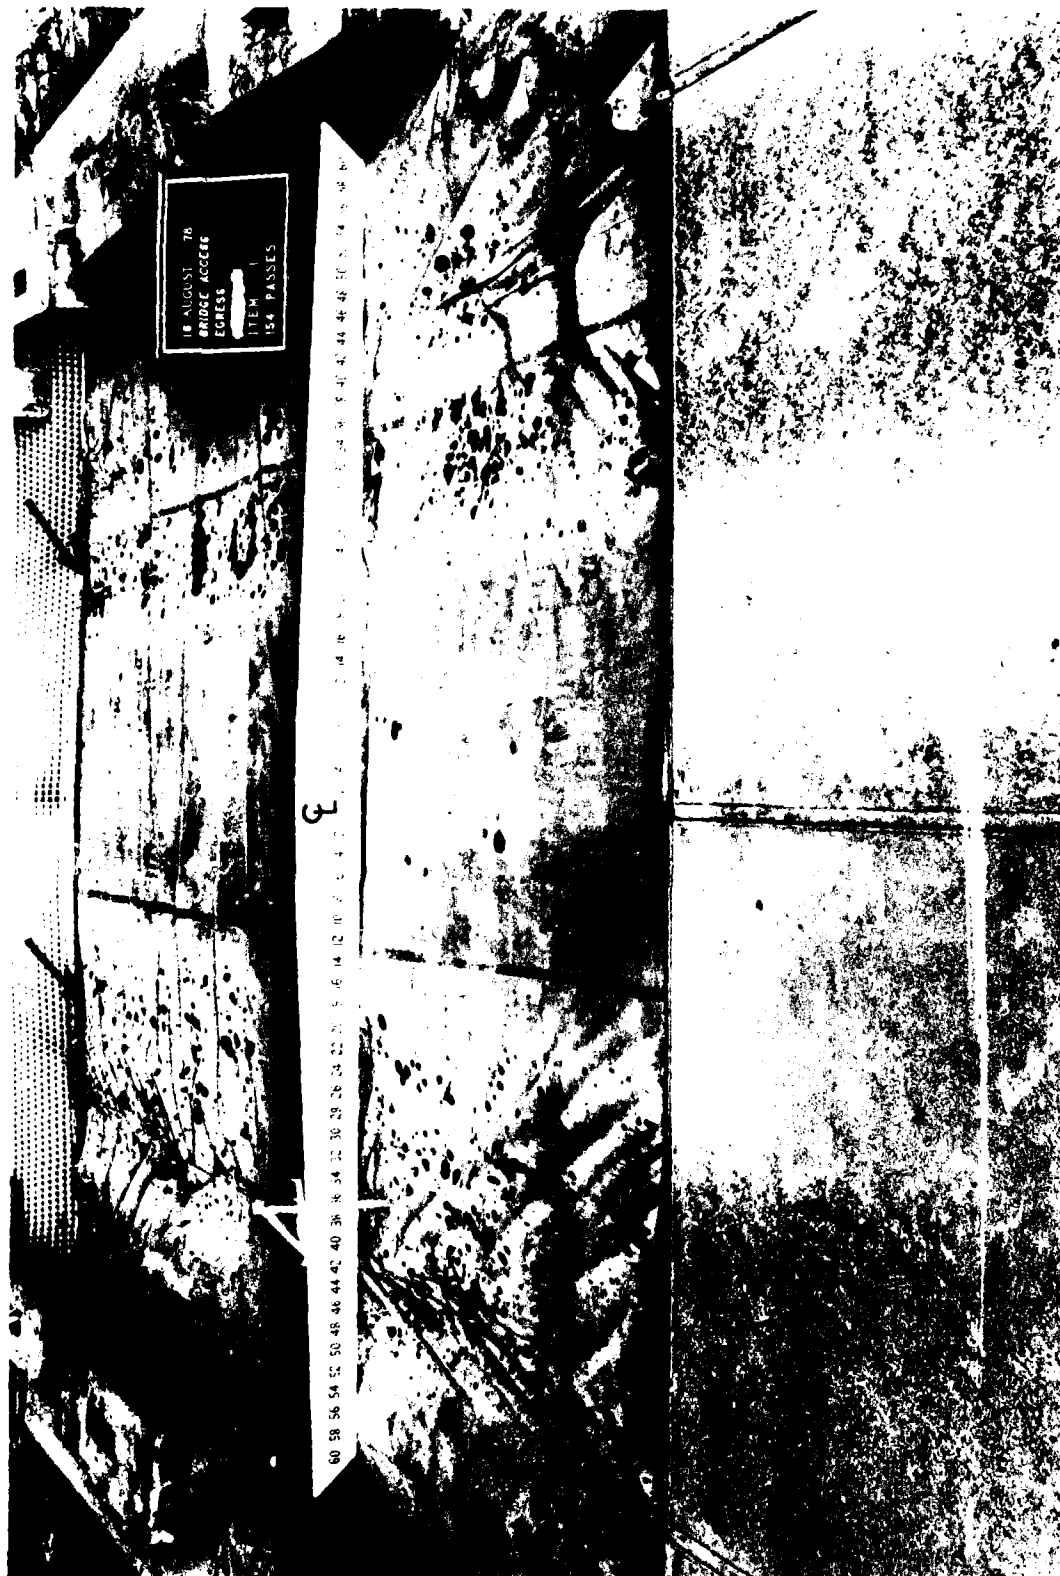
Incl 60.

Item 1 after 154 passes of traffic

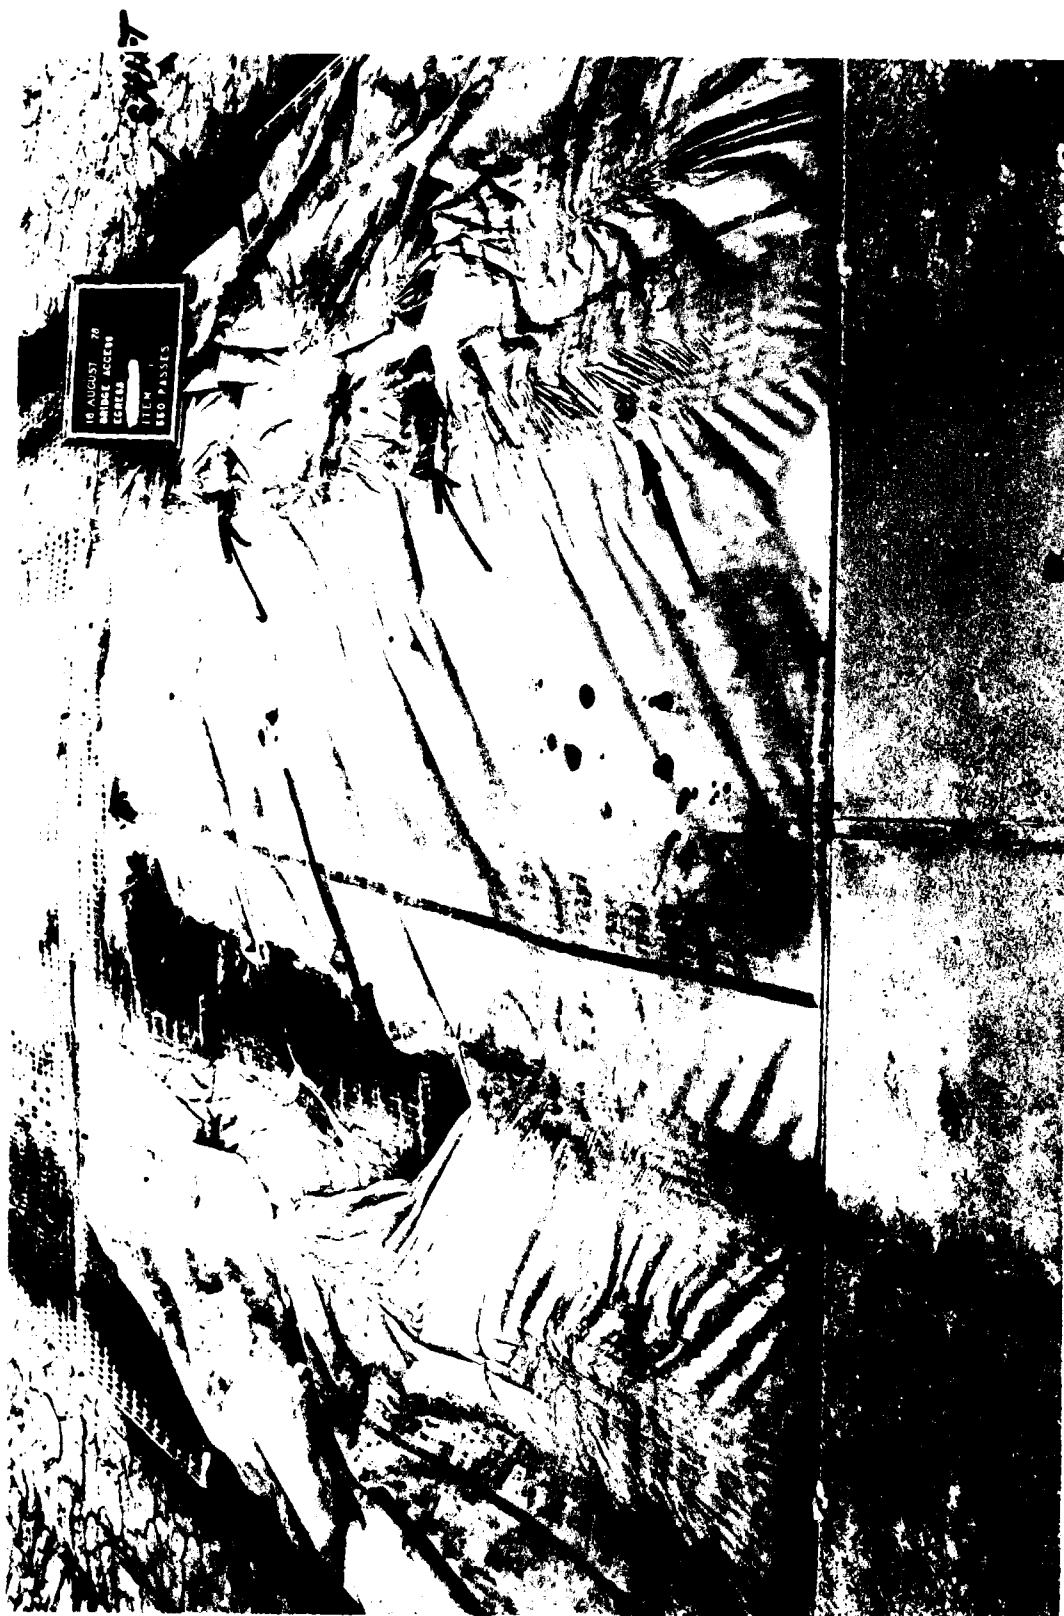
Incl 61.

Item 1 after 550 passes of traffic

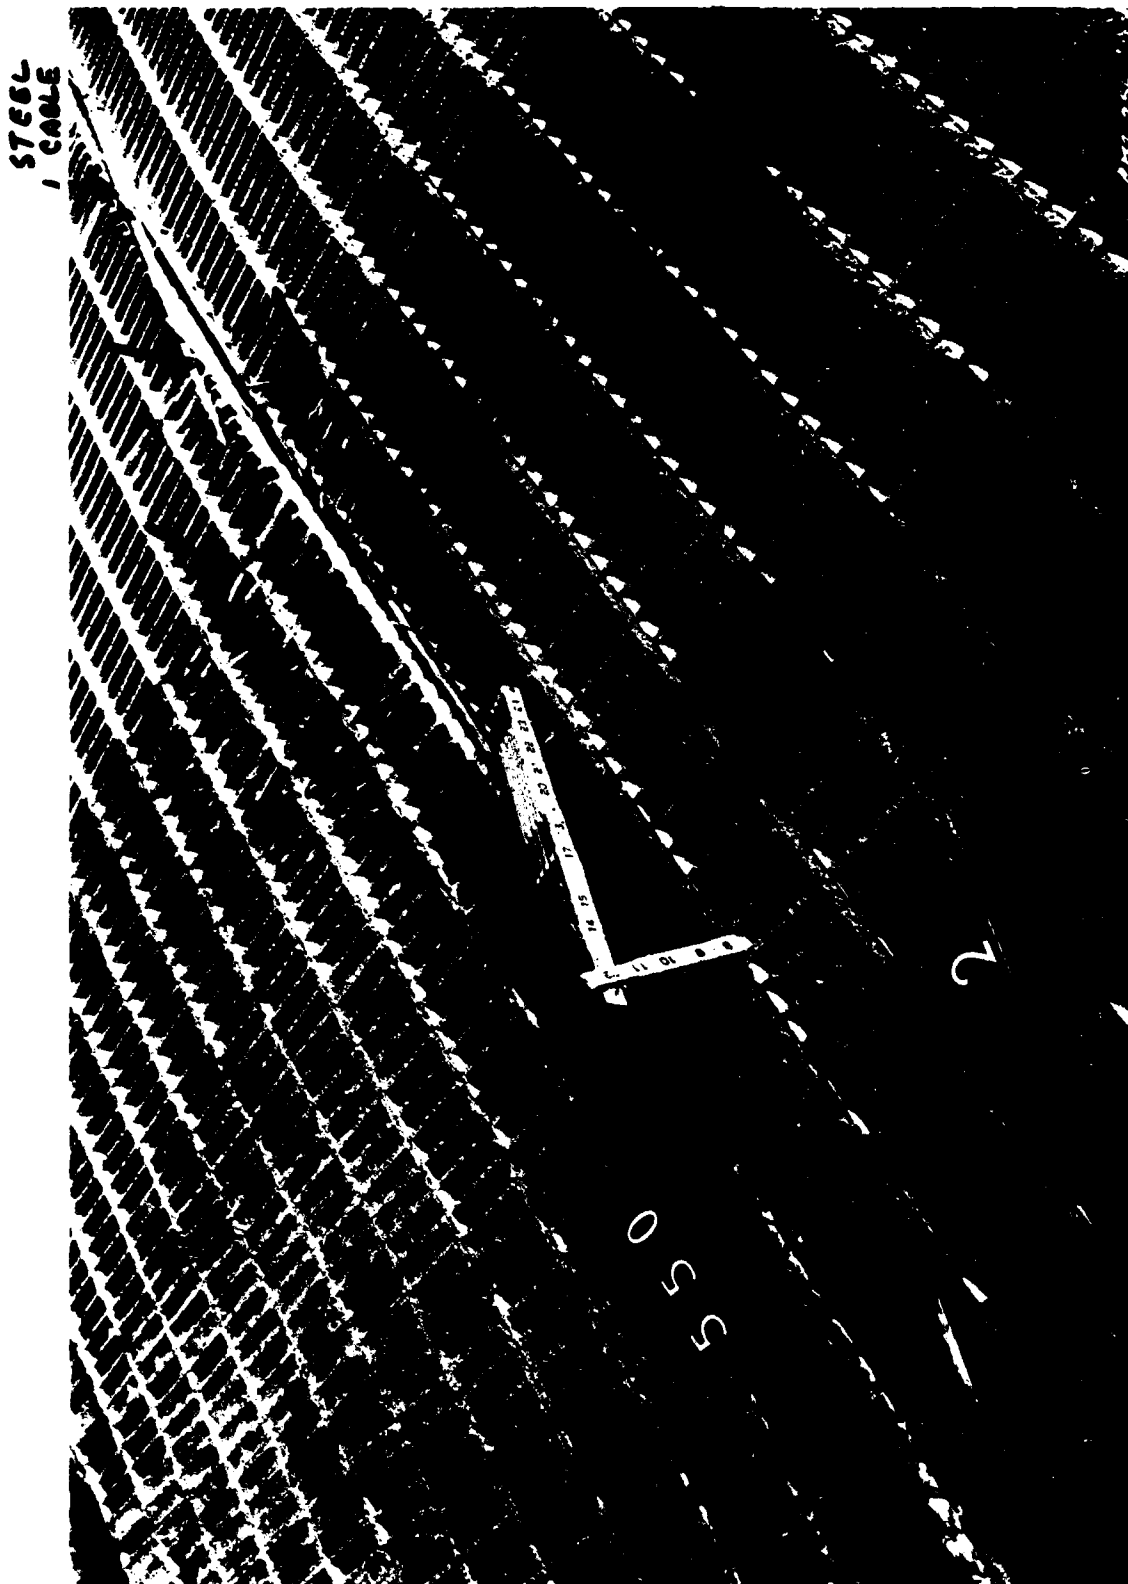
INCL 72

Panels in item 2 after 550 passes
of traffic

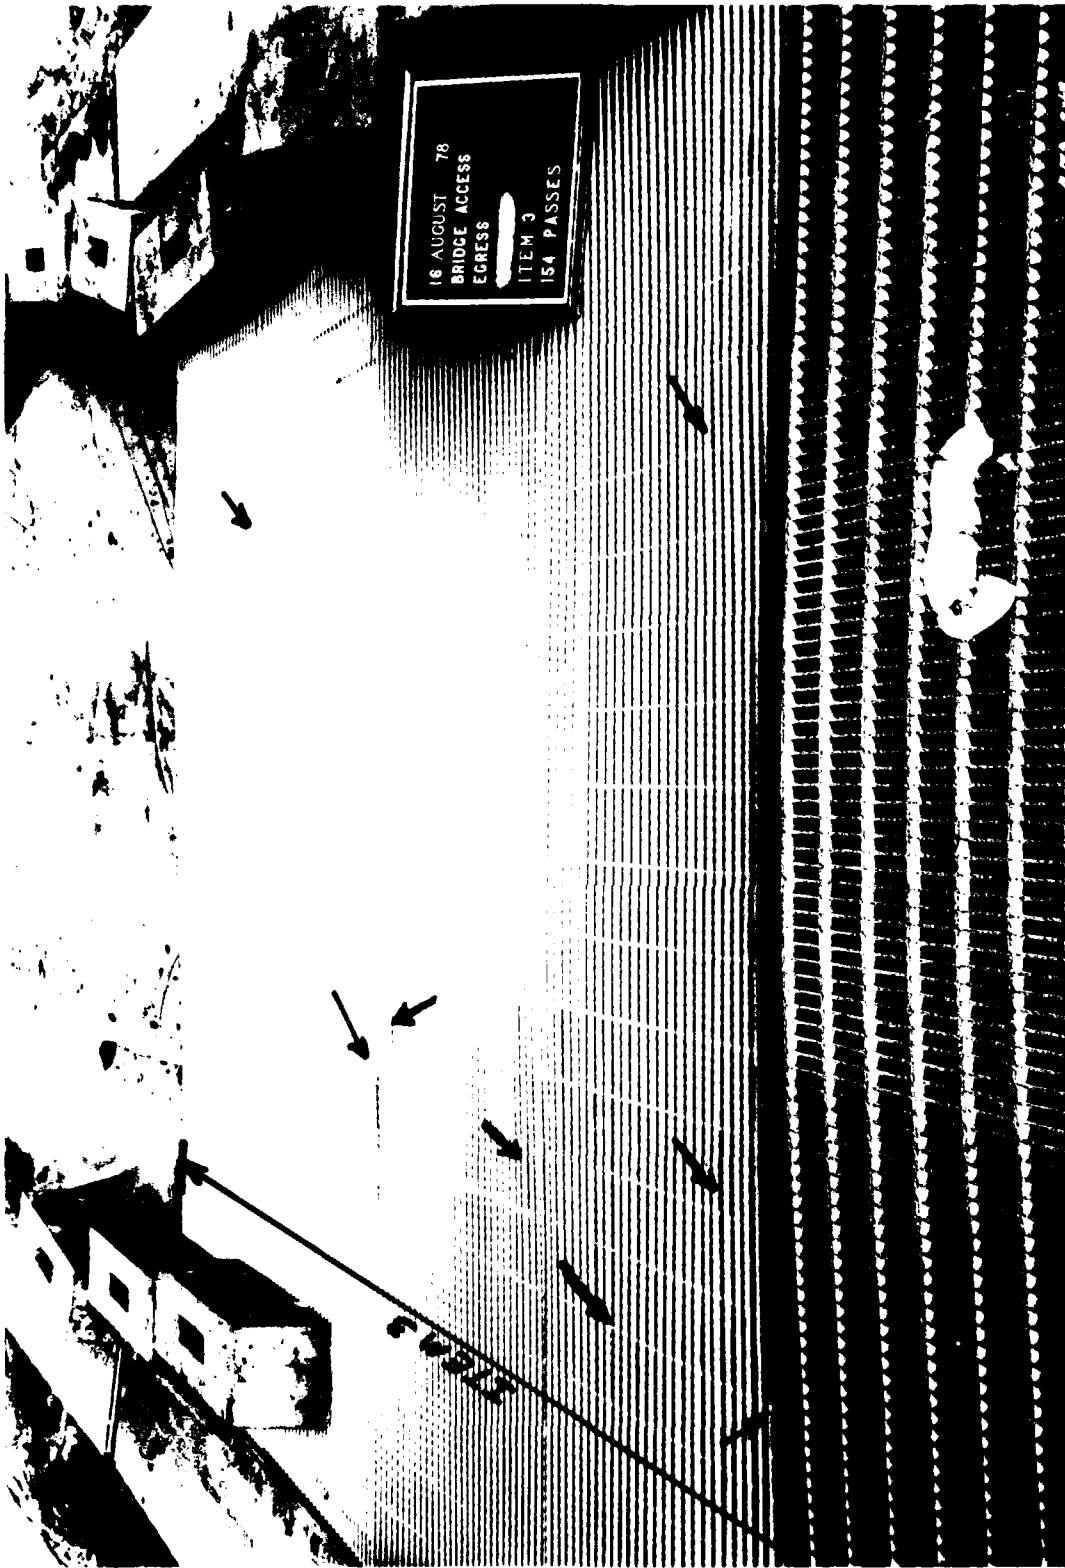
Item 3 after 154 passes of traffic

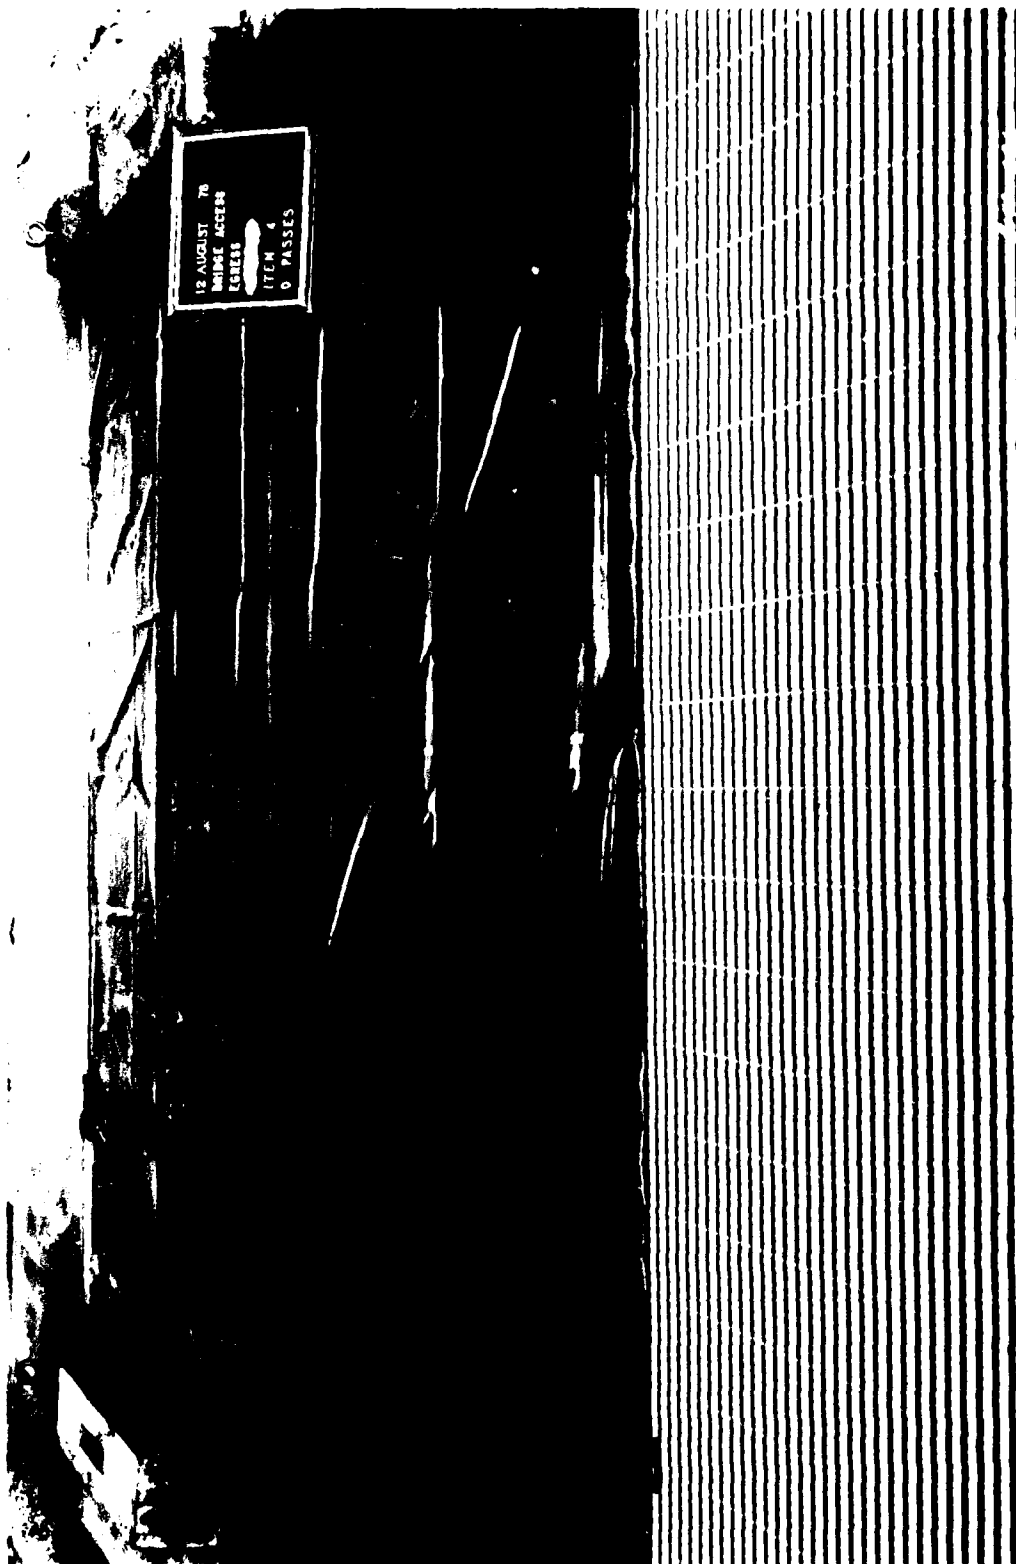
Incl 78.

Item 4 prior to traffic

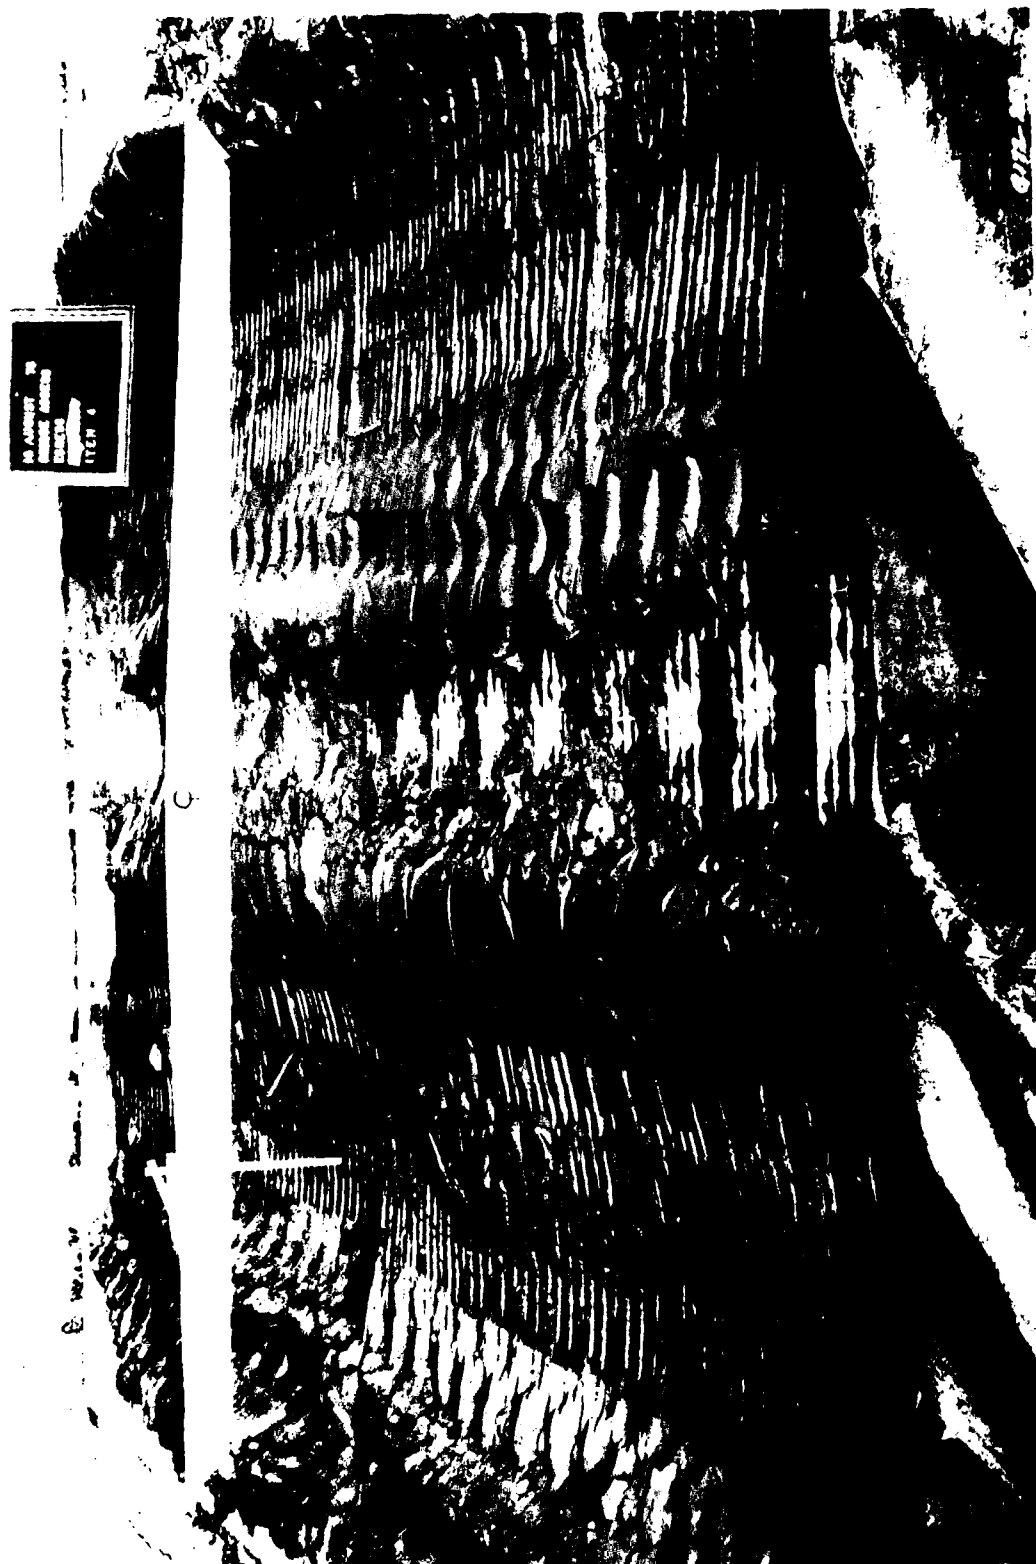
from 4 after 154 passes of traffic; membrane removed from surface

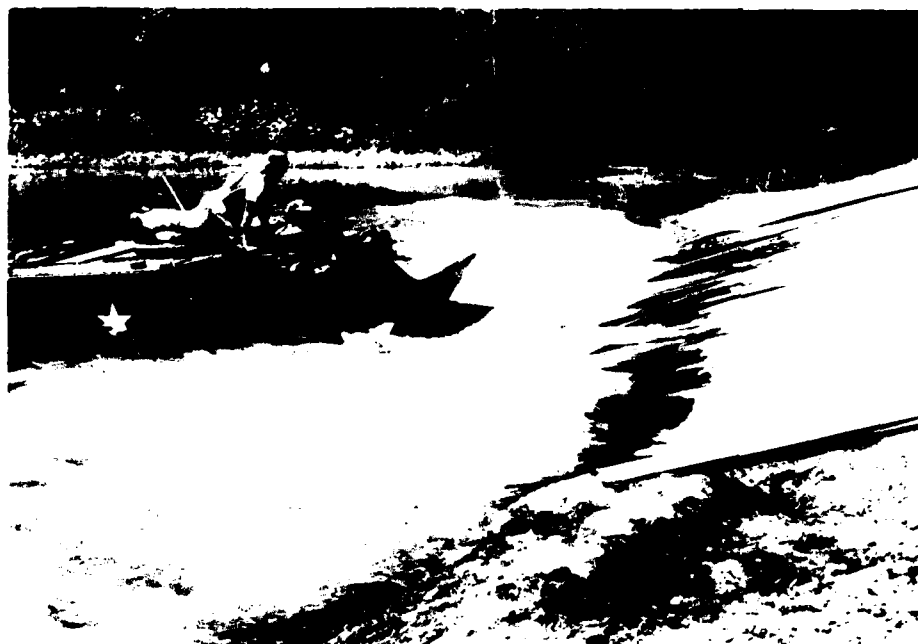
h. M113 APC attempting to climb onto membrane on slope

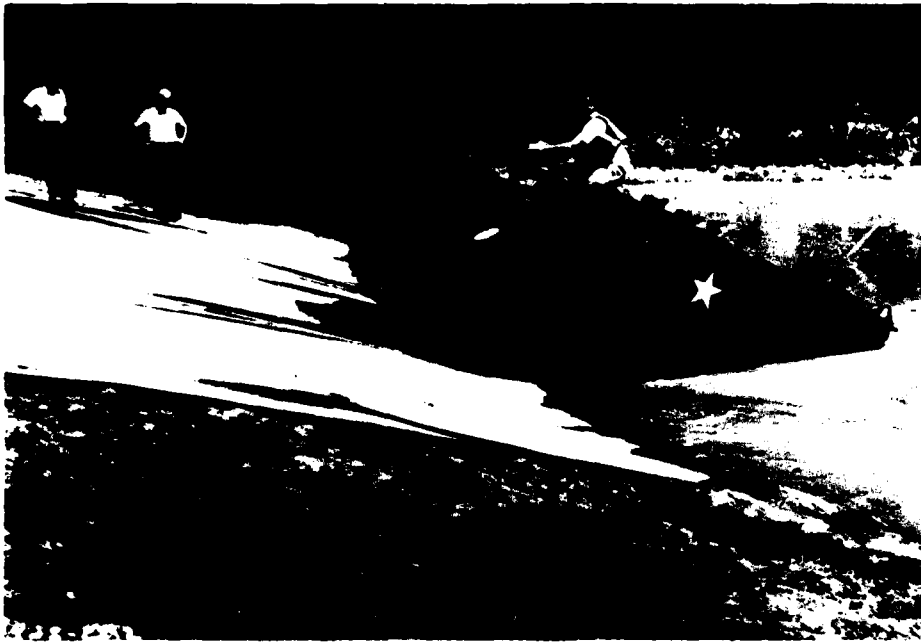
i. M113 APC almost up out of water and onto slope

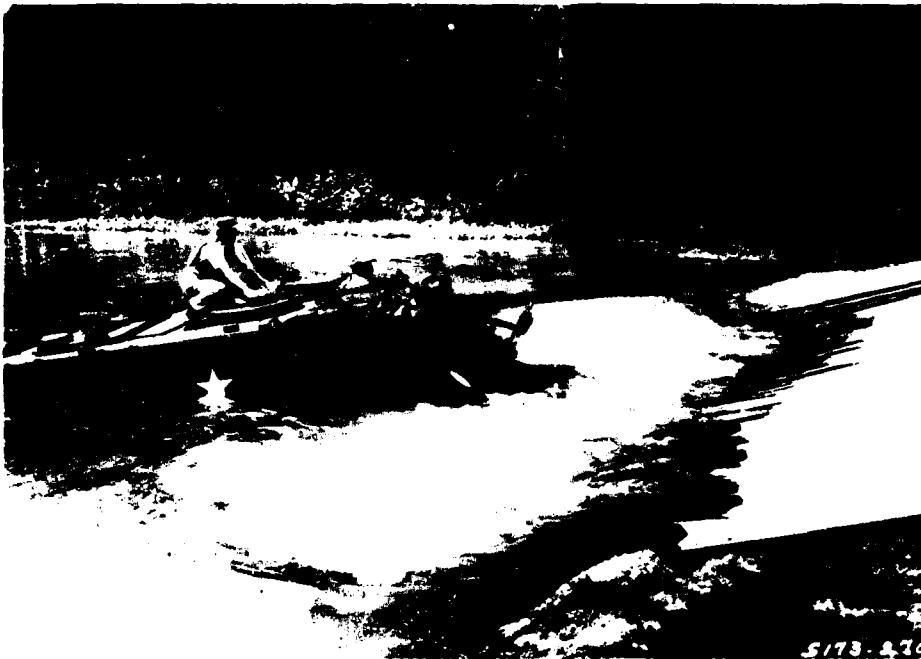
j. Vehicle sliding back into water after spinning on membrane

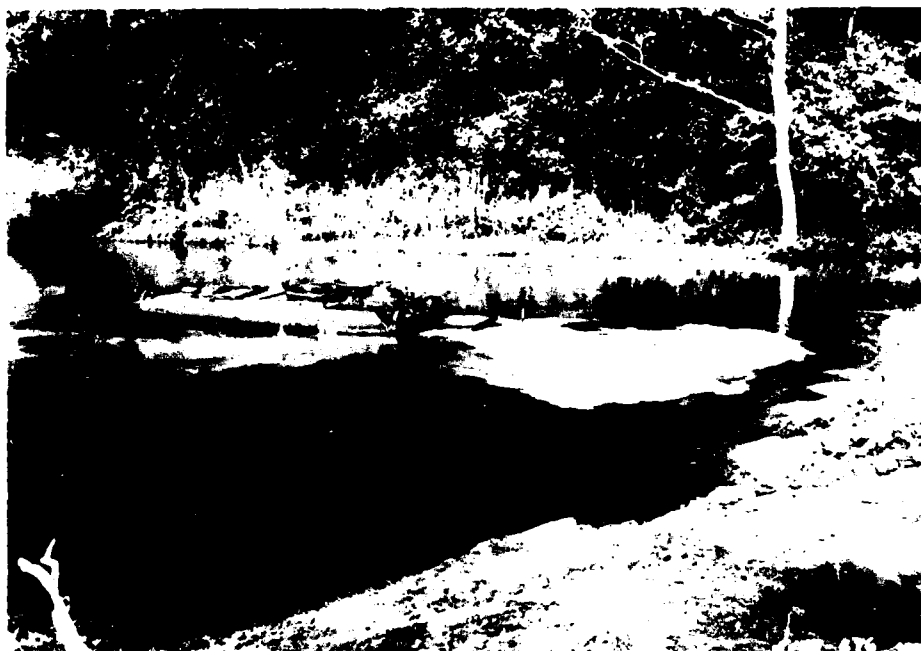
o. After repair vehicle attempted to climb unsurfaced slope

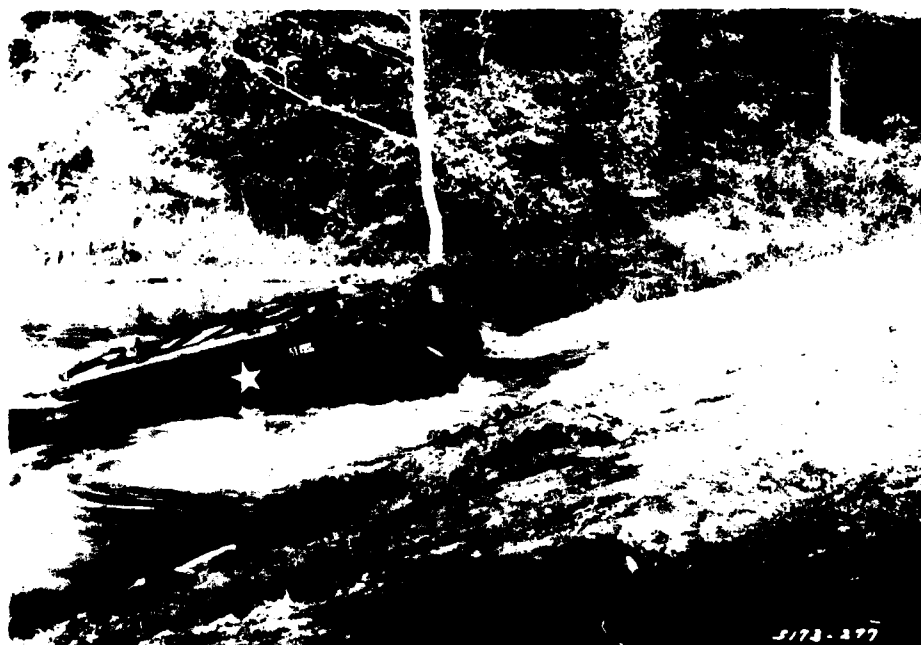
p. Vehicle just climbing onto base of slope at water's edge

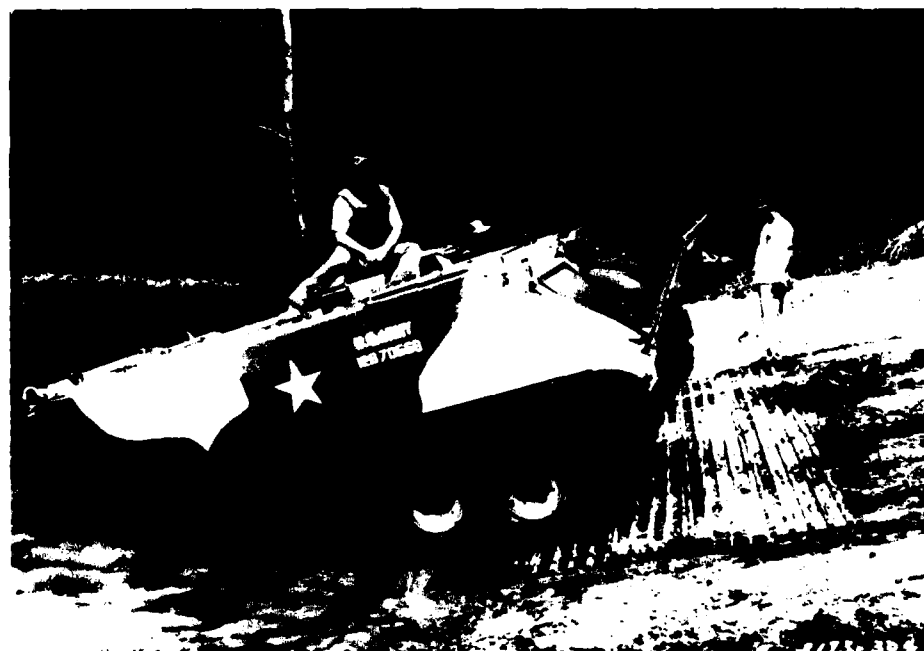
f. M113 APC almost successfully exiting lake (note mat was pulled downslope until "go" condition encountered with mat located as shown in Photo H5g)

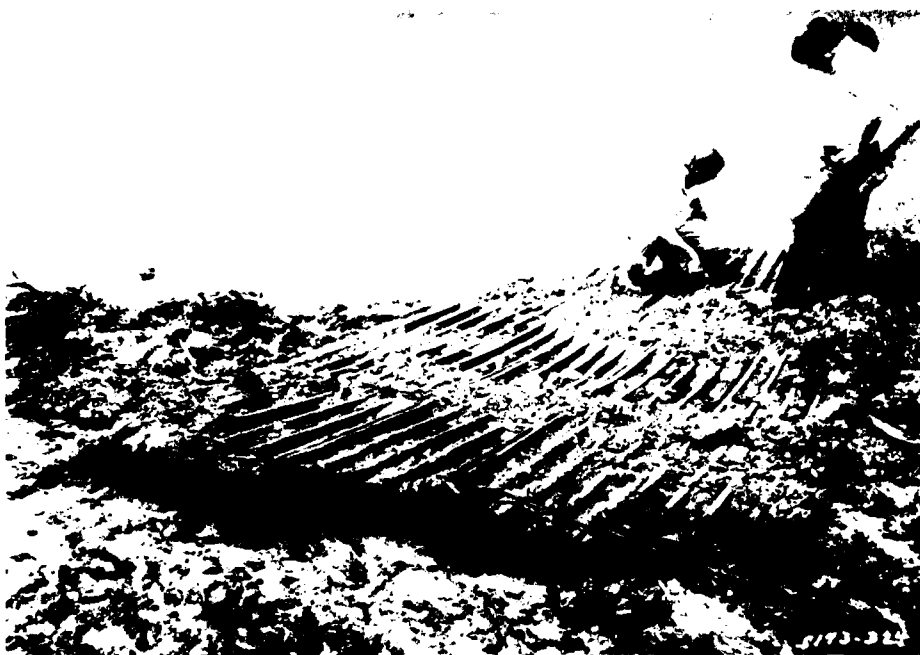
heavily damaged by vehicle traffic, especially at the panel joints (Photo H10). Evidently, the rolled edge, when placed downslope, was rather easily opened up and unrolled by the track system spinning on the rolled section. After unrolling, the panels then easily disconnected with little effort.

a. View of mat, inverted, rolled edge toward lake, after tests

Photo H10. Damaged M8A1 after vehicle tests
Brown Lake area (Sheet 1 of 2)
